Monitoring Data Record

Project Title: R-2248BB – Charlotte Outer Loop COE Action ID: 200131321
 Stream Name: UT Thomas Pond (Site 9) DWQ Number: 011231
 City, County and other Location Information: Mecklenburg County, Charlotte Outer Loop, NC 27 Exit (Mount Holly Road)
 Date Construction Completed: April 2005 Monitoring Year: (1) of 5
 Ecoregion: _____ 8 digit HUC unit 03050101
 USGS Quad Name and Coordinates: _____

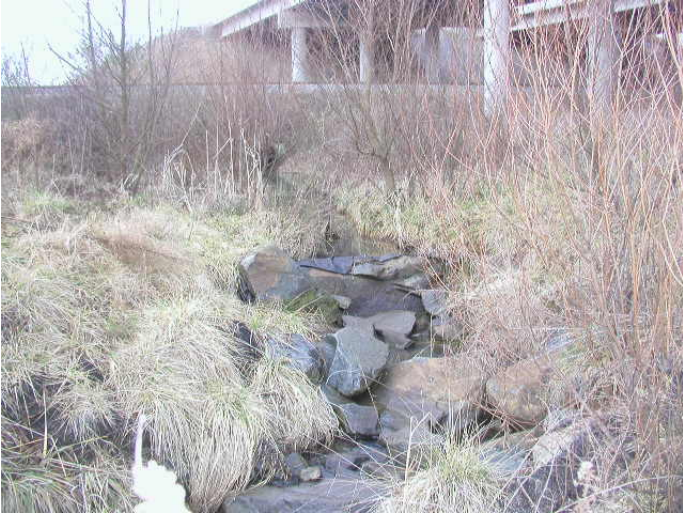
UT Thomas Pond stream relocation is stable for the Year 1 Winter evaluation. The crossvane at Photo Point #1 (Upstream) has water piping under crossvane but the stream is stable at this time. There was also some minor bank scouring at the outlet end of the box culvert at Sta 219+80 -L- on the left and right bank (additional photo showing this area). NCDOT will continue to monitor this stream relocation for channel stability.

Date 2/6/08	Station 17+40 Y-10	Station 219+80-L-	Station Number	Station Number	Station Number
Structure Type	Crossvane @ inlet of pipe				
Is water piping through or around structure?	Water is piping under crossvane.				
Head cut or down cut present?					
Bank or scour erosion present?		Minor bank scouring on left and right bank @ outlet end of box culvert			
Other problems noted?

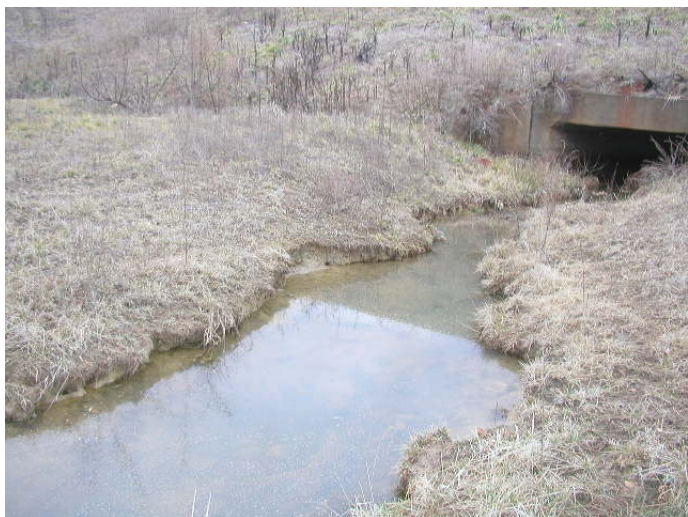
The area at the outlet end of the box culvert at Sta. 219+80-L- lacks woody vegetation.

Bank Scouring @ Sta. 219+80-L-

Estimated causes, and proposed/required remedial action: This area will be supplementally planted
with bareroot seedlings
